**DEPARTMENT OF TRANSPORTATION****DIVISION OF ENGINEERING SERVICES**

Contract #: 04-0120F4Cty: SF/ALA Rte: 80 PM: 13.2/13.9File #: 69.28**WELDING INSPECTION REPORT****Resident Engineer:**Pursell, Gary**Address:** 333 Burma Road**City:** Oakland, CA 94607**Report No:** WIR-008688**Date Inspected:** 23-Aug-2009**Project Name:** SAS Superstructure**OSM Arrival Time:** 700**Prime Contractor:** American Bridge/Fluor Enterprises, a JV**OSM Departure Time:** 1900**Contractor:** Zhenhua Port Machinery Company, Ltd (ZPMC), Changxing Island **Location:** Shanghai,China**CWI Name:** Lv Li Qing / Shen Fu You**CWI Present:** Yes No**Inspected CWI report:** Yes No N/A**Rod Oven in Use:** Yes No N/A**Electrode to specification:** Yes No N/A**Weld Procedures Followed:** Yes No N/A**Qualified Welders:** Yes No N/A**Verified Joint Fit-up:** Yes No N/A**Approved Drawings:** Yes No N/A**Approved WPS:** Yes No N/A**Delayed / Cancelled:** Yes No N/A**Bridge No:** 34-0006**Component:** OBG Assembly**Summary of Items Observed:**

# WELDING INSPECTION REPORT

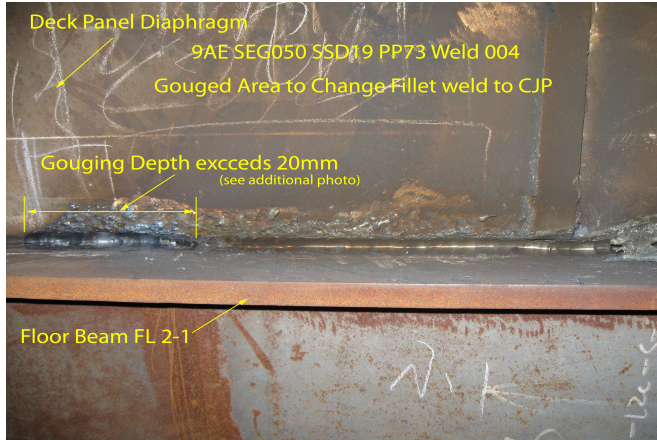
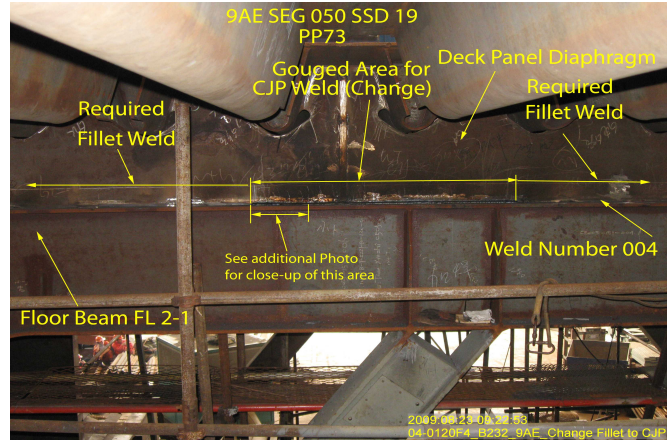
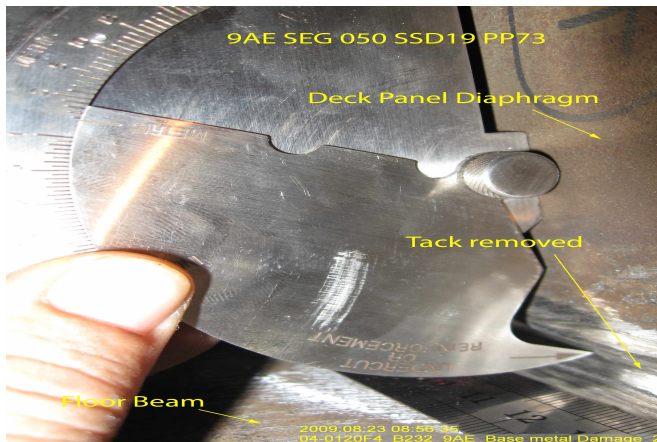
This Quality Assurance Inspector (QA) observed that the contractor has removed base metal on deck panel diaphragm on assembly 9AE SEG 050 SSD19 PP73 weld number 004. There are twenty – one (21) locations where ZPMC found tacks with crack like linear indications on all or part of the 21 tack welds, using the magnetic particle (MT) inspection method. In an attempt to remove these tack welds using air carbon arc gouging a large portion of base metal was removed (minimum 4mm / maximum 10mm) on all 21 areas. An Incident report will be written on this issue. See photographs for more information.

This Quality Assurance Inspector (QA) observed that the contractor appears to have deviated from the weld joint design specified on the approved drawings. The contractor appears to have changed the weld joint from a Fillet Weld to a Complete Joint Penetration (CJP) weld with a backing weld. This deviation was performed without the Engineers approval. According to the ZPMC QC inspector, the weld design was changed in order to compensate for a joint root opening in excess of 5mm. This condition exists in the following locations; OBG segment 9AE @ PP072 for weld joining SEG 050 SSD19 PP72 weld 004/005 and OBG segment 9AE @ PP073 for weld joining SEG 050 SSD19 PP73 weld 004/005. An incident report will be written on this issue.
